Re: April 2016 Monthly Progress Report  
Administrative Settlement Agreement and Order on Consent for Removal Action  
U.S. EPA Region 10 Docket No. CERCLA 10-2009-0255  
Gasco Sediments Site within the Portland Harbor Superfund Site

Attachment A      Monthly Visual Monitoring Report for Pilot Cap Vicinity

## Visual Observations Log Form

**Monitoring Period:** Monthly (Year 10)— April 2016

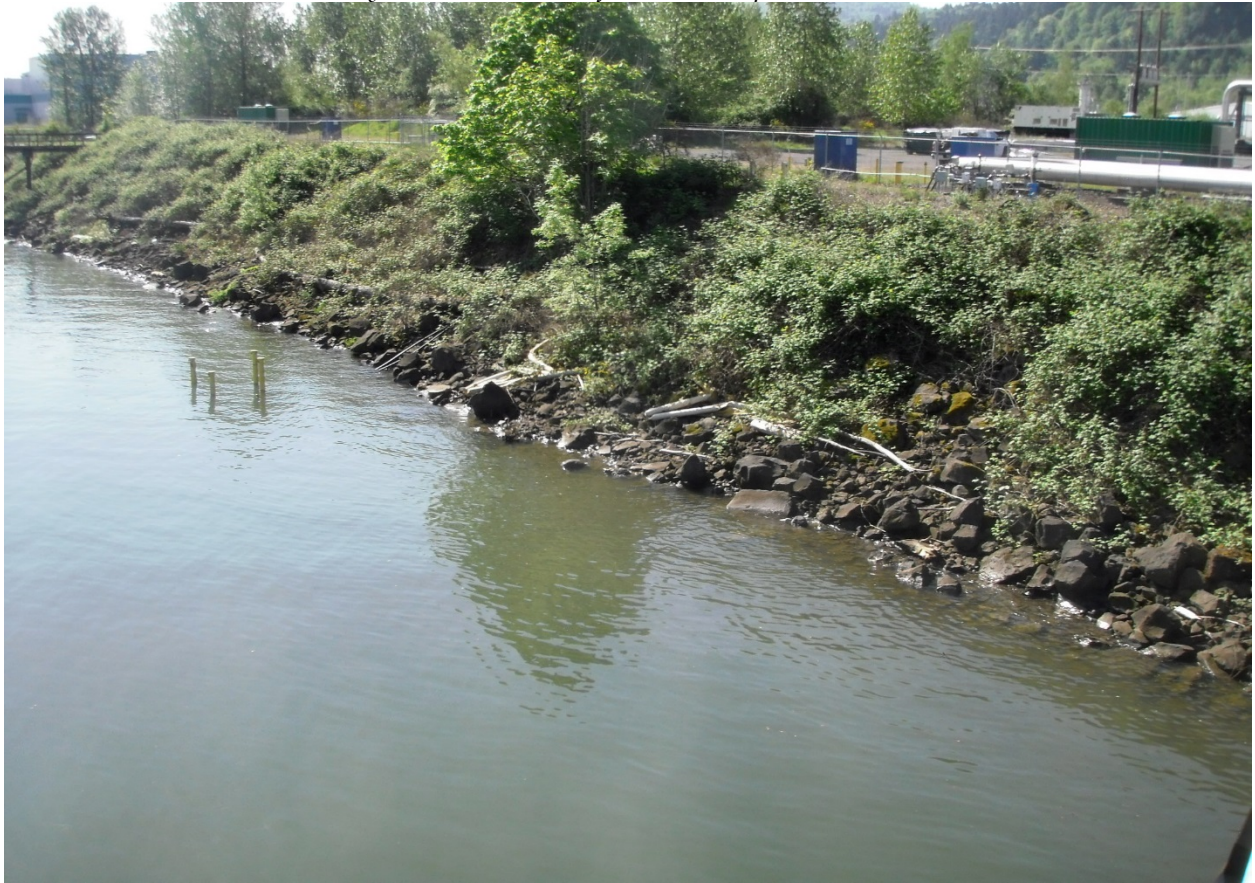
**Observations of Erosion/Deposition:** No erosion/deposition is evident along the shoreline. The shoreward extent of the cap was not visible due to high river water elevation, and the extents of the organoclay mat material were also submerged. (Photo 1).

Photo 1 — *River level currently above the extent of sediment cap (4/20/16):*

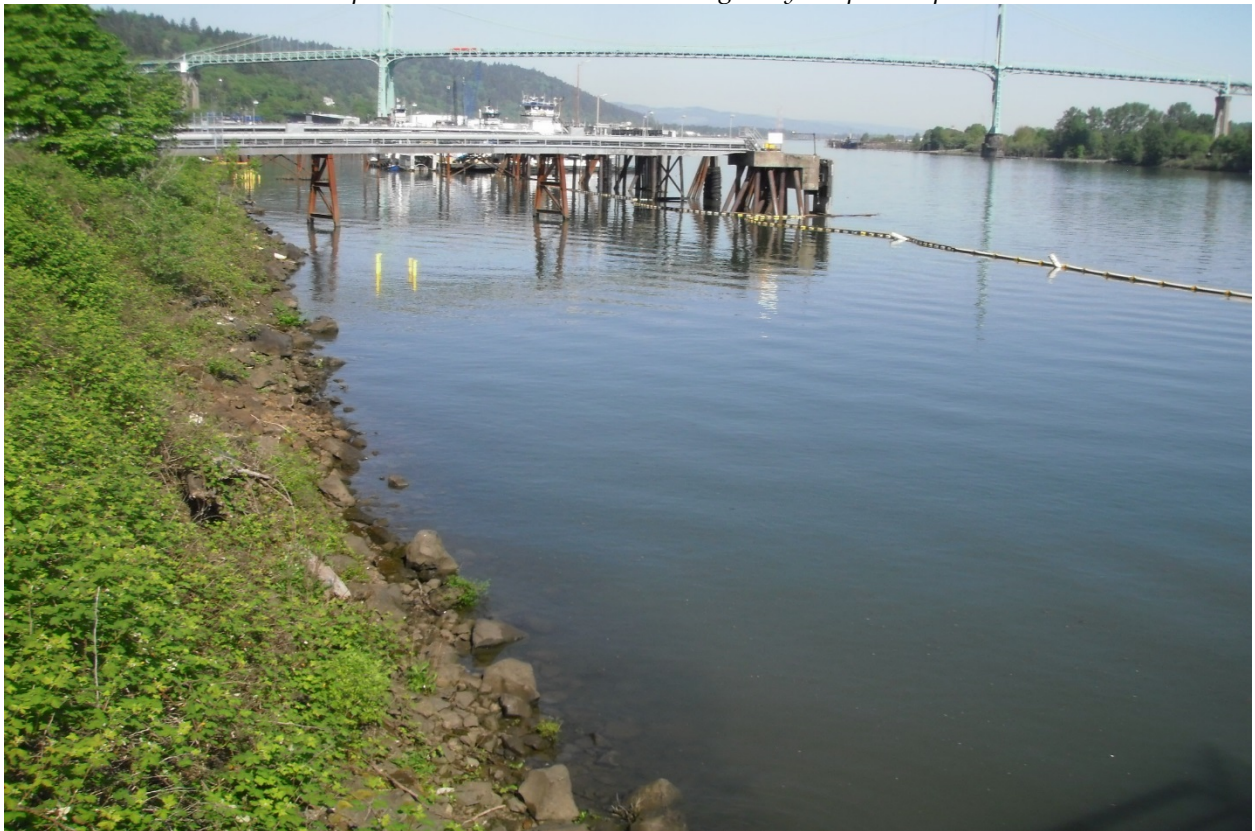
**Observations of Long-term Controls (i.e., oil booms, organo-clay mat, etc.)** During the observation, the FAMM containment boom was placed across the cap area from the ship dock to an anchor point riverward of the upriver dolphin. Two buoys that identify the cap area to mariners are in place as installed. The position of the FAMM oil boom and warning buoys, and a general overview of the site shoreline, is shown in Photo 2.

Photo 2 — *FAMM oil boom placement and mariner warning buoys at pilot cap area. (4/20/16):*

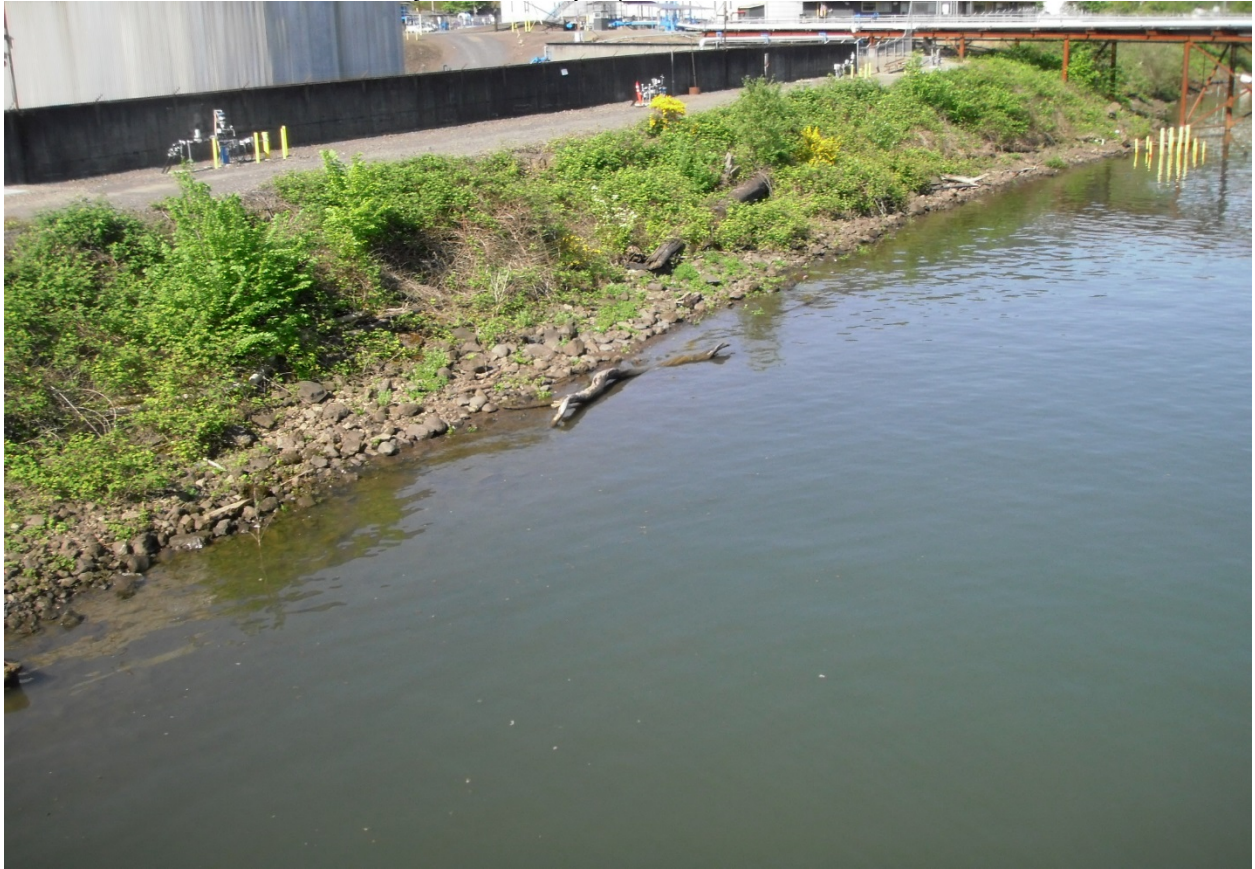
**Other Comments:** No sheen is evident in or around the cap area. Photo 3 shows the water surface and shoreline immediately downriver of the sediment cap.

Photo 3 — *Conditions immediately downriver of cap area (4/20/16):*
